**RABEAA POINT OF ENTRY
SCREENING FACILITY
RABEAA, IRAQ**

**SIGIR PA-09-173
JANUARY 11, 2010**

Summary of Report: PA-09-173

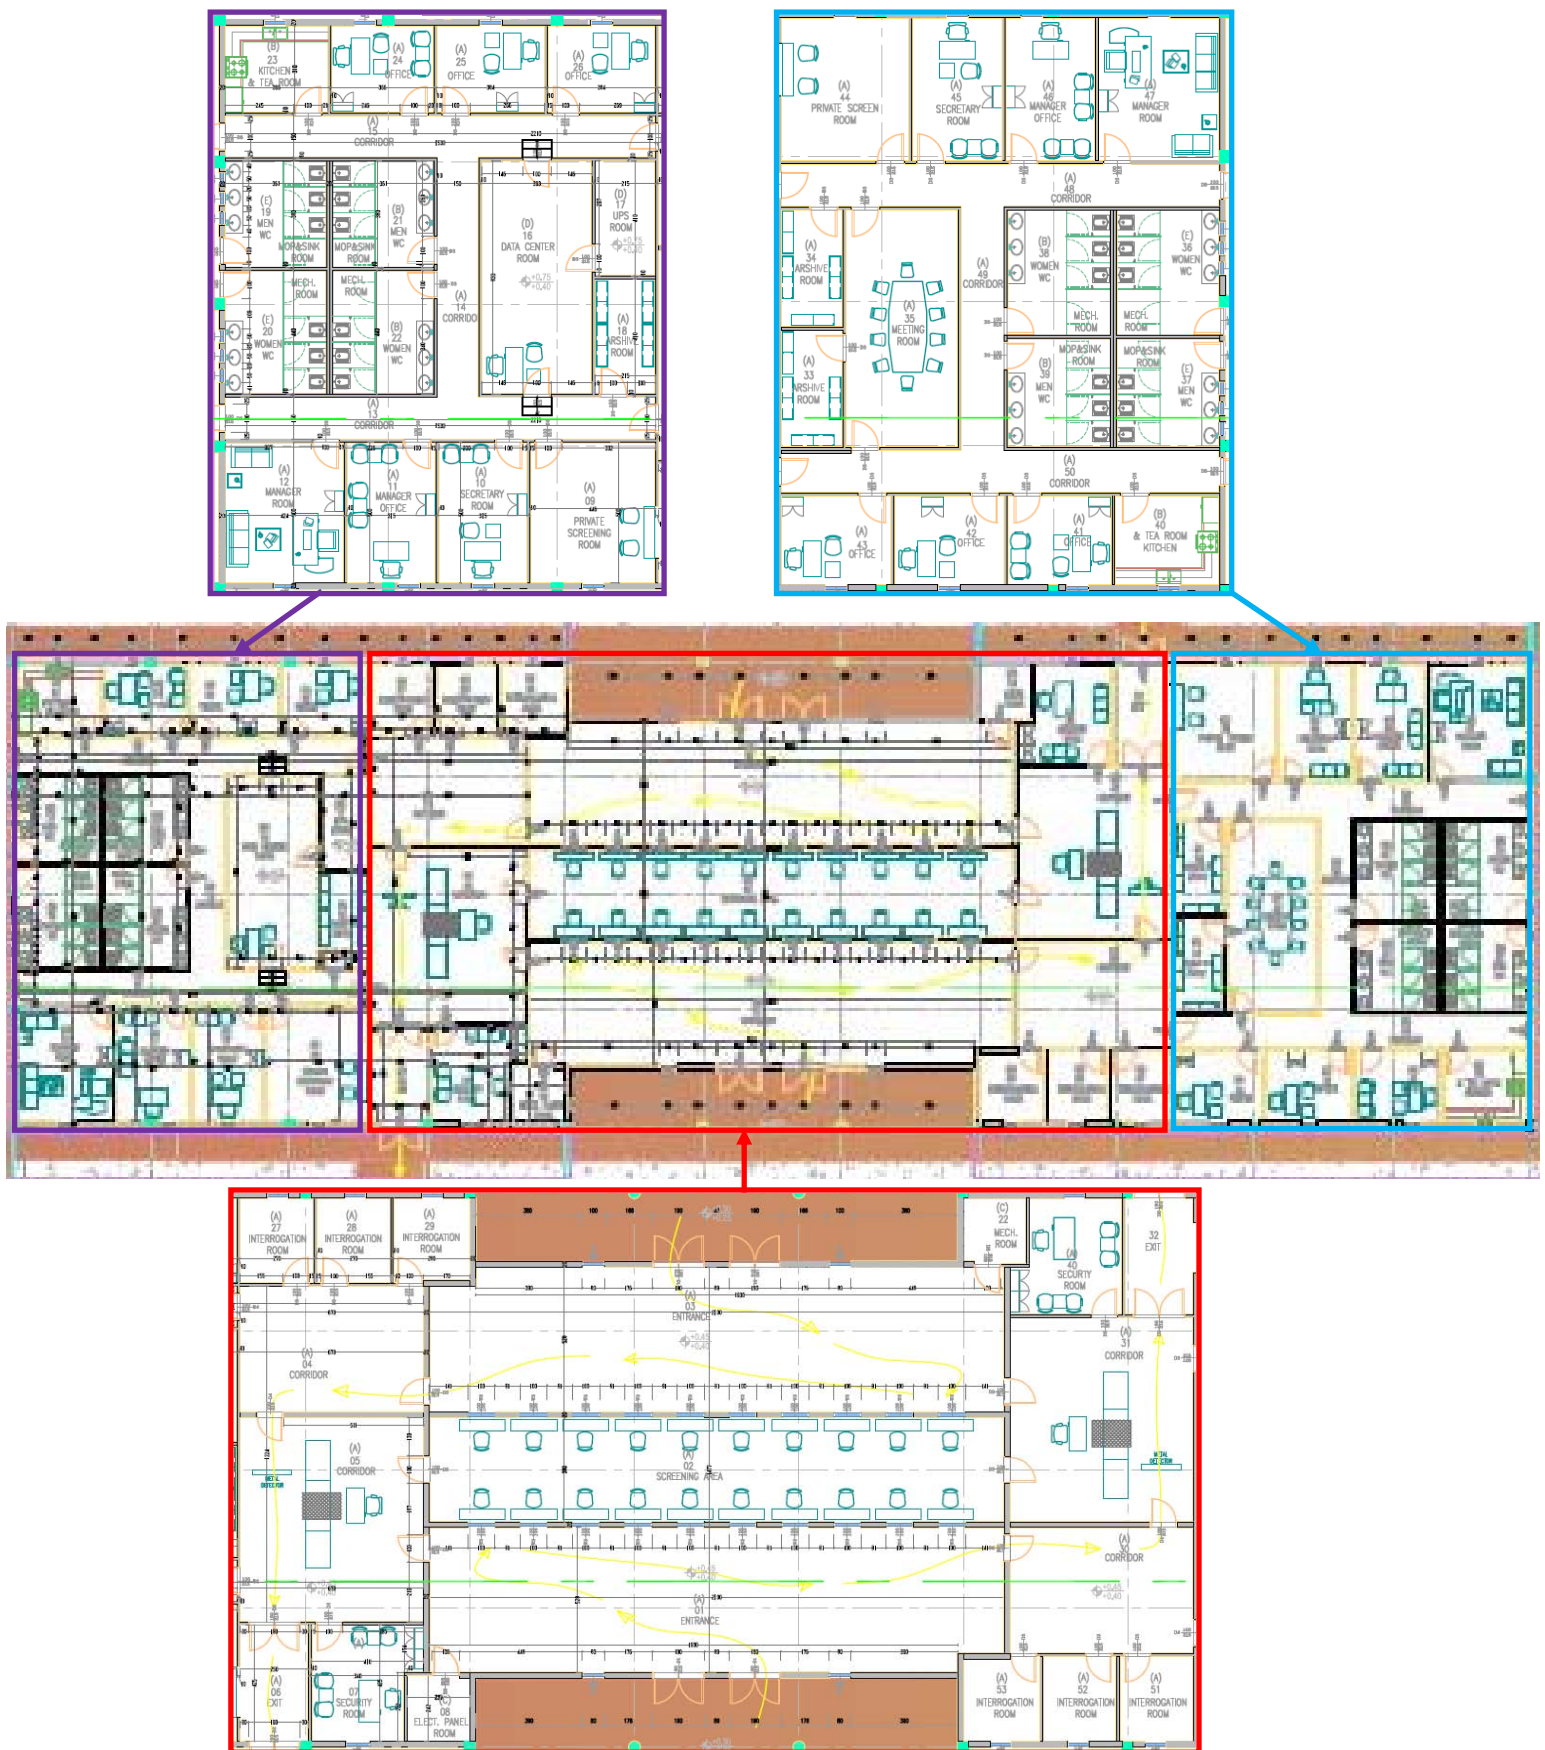
Figure 2. Screening facility (Courtesy of USACE)

The SOW called for the contractor to construct a 1,230 square meter, heated and cooled, screening facility. The screening facility building is divided into three separate areas that consist of two main offices and a screening area (Figure 2). The screening facility building contains the following areas and/or rooms:

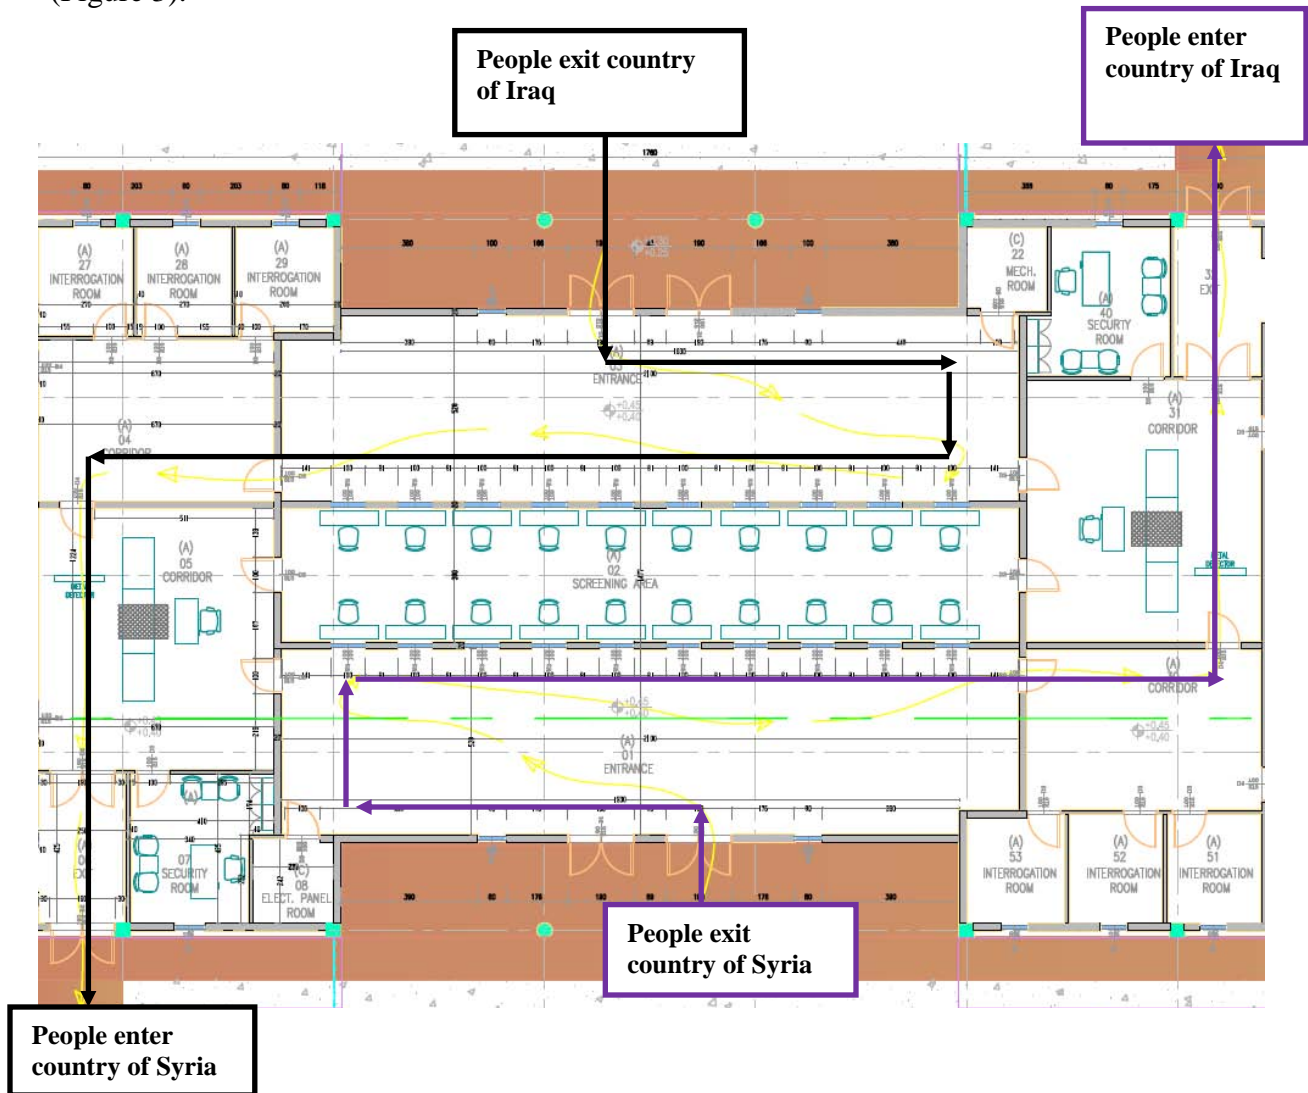
Figure 3. Foot traffic flow through the screening area (Courtesy of USACE)

The screening area is located in the center of the screening building, and is separated from the customers by six bank-type windows that are blast resistant on each side. One side of the screening area works traffic from Syria into Iraq, and the other side of the screening area works traffic from Iraq into Syria. Upon clearing the windows, the individual screened passes through an entrapment area before proceeding to the next screening area that contains a metal detector, and then proceeds into the other country (Figure 3).

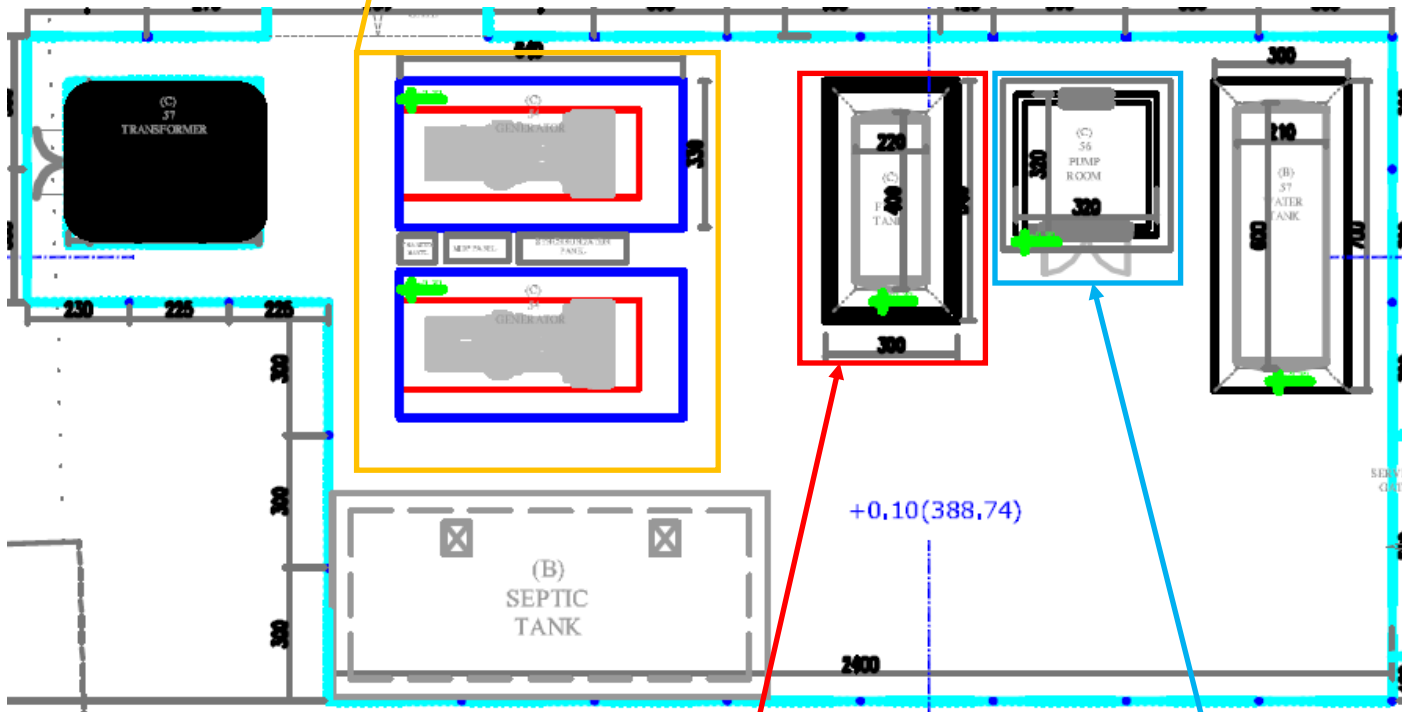
Figure 4. Outlying support for screening building (Courtesy of USACE)

To support the Rabeaa POE screening facility, the SOW called for the contractor to provide 12,000 liters of water storage, provide and install at least a 2,000-liter septic tank, and provide and install a power generation plant with a minimum of one, one-megawatt diesel generator with two 2,000 liter fuel tanks and a manual transfer switch (Figure 4). Also, the contractor was to connect the facility to the water distribution system, sewage system, and commercial power, if feasible.

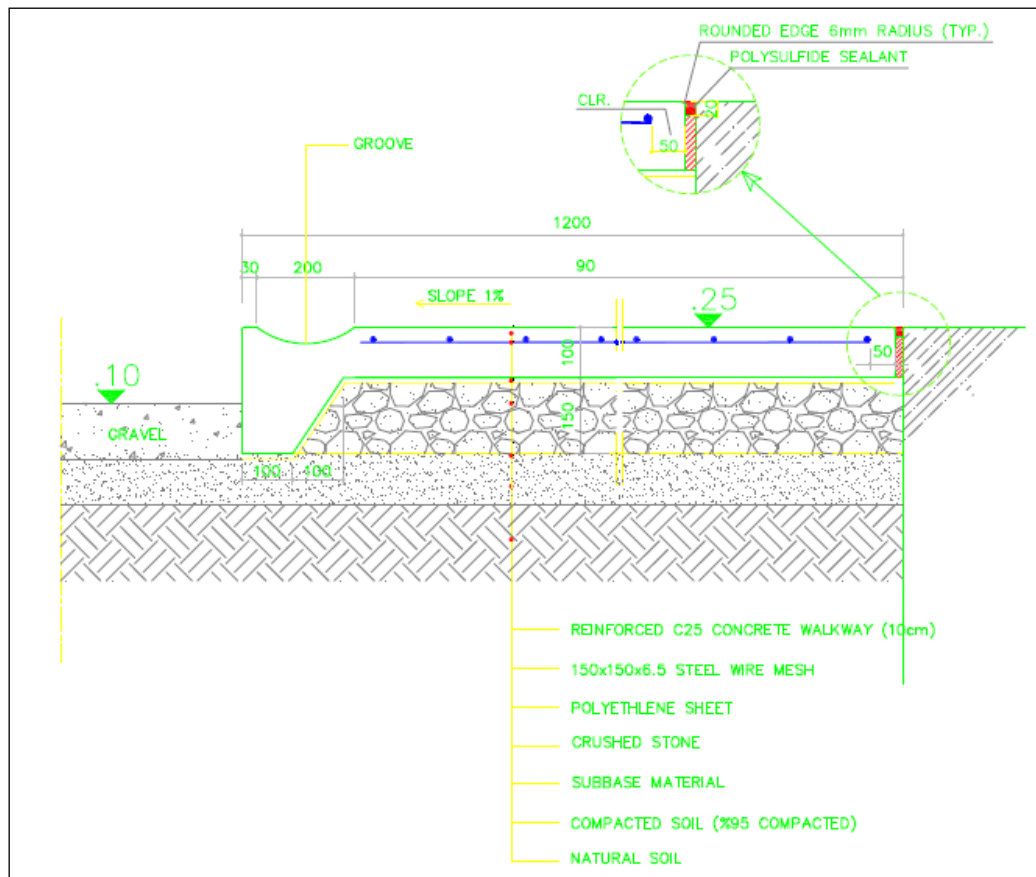
Figure 5. Sidewalk detail per the 100% design drawings (Courtesy of USACE)

At the time of the site assessment, the exterior sidewalk was partially constructed; the construction was determined to be lacking an isolation joint next to the building, control joints, and a 200mm groove (Site Photo 9). Both the isolation joint and the groove were included in the 100% drawings submitted for approval (Figure 5). The control joints (contraction joints) were required every 1.2 meters (m) per a special note on the plans.

- a. Improper jointing and unlevel construction of the concrete floor slab and cracking of the thin mortar overlay.
- b. Exterior sidewalk construction that was lacking control joints, a 200mm groove, and isolation joints next to the building.
- c. Construction of the raised concrete pad of the water pump house floor that was not square and did not allow for access to one exterior wall.

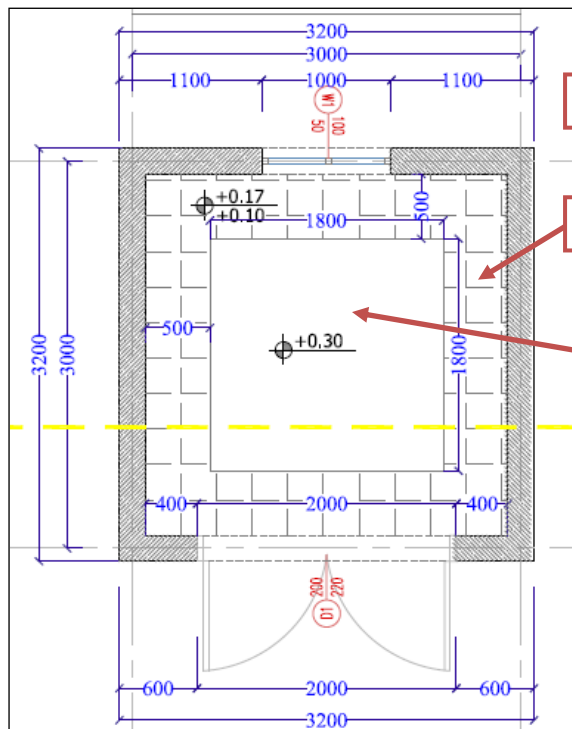
Figure 6. 100% Water pump room floor plan drawing (Courtesy of USACE)

Although the construction of the water pump house was partially completed, SIGIR noted that the construction of the raised concrete pump pad was not constructed in accordance with the drawings (Figure 6 and Site Photo 10). Specifically, the raised floor as submitted on the plans was a 1.8m square raised concrete pad. The actual construction of the raised concrete pad was not configured in a square and did not allow for access against one exterior wall. Once the booster pumps are placed on the concrete pad, the access to the electrical control panel could be impeded. The original design allowed for unimpeded access all around the raised pump pad.
